DAMAGEABILITY TESTS OF MINICARS RSV

R. Garn
S. Davis

Dynamic Science, Inc.
A Talley Industries Company
1850 West Pinnacle Peak Road
Phoenix, Arizona 85027

DECEMBER 1980
FINAL REPORT

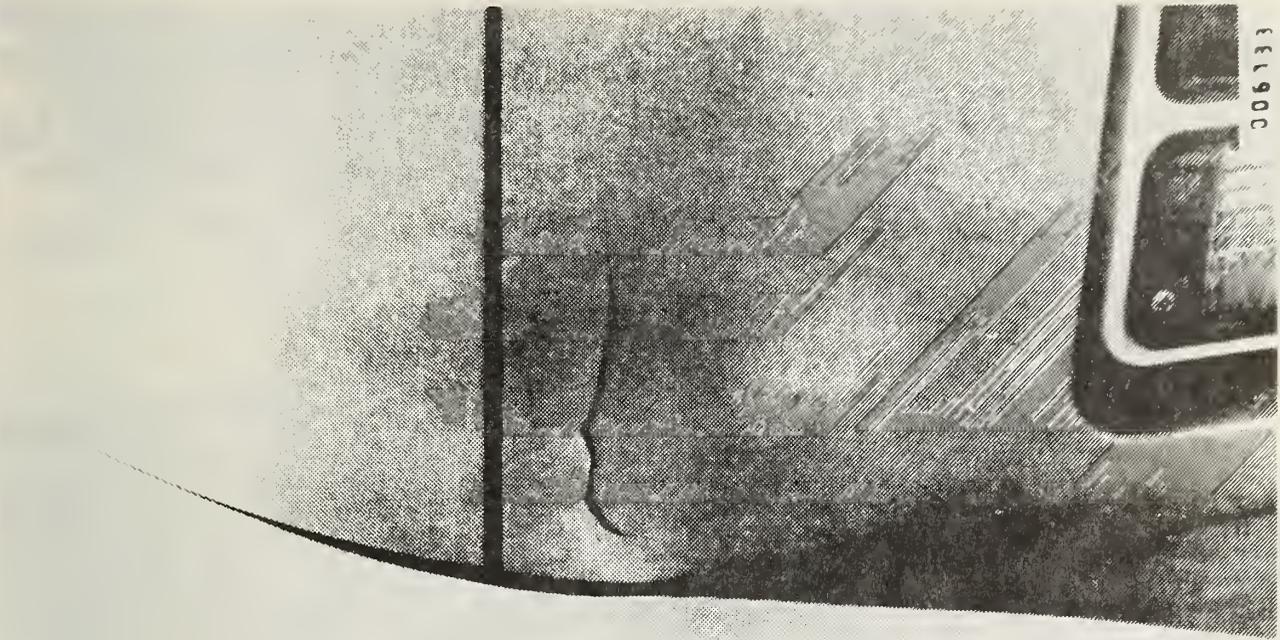
Damage to the M5-11 target vehicle was minor and apparently cosmetic only. One small crack appeared at the lower left corner of the taillight panel, adjacent to the rear fender seam. During vehicle construction, this area was finished for painting by covering with a layer of body putty. The crack observed appeared to be in the body putty only (see Figure C-3).

FIGURE C-3. POST-TEST NO. 1, CRACK IN TAILLIGHT PANEL OF M5-11 TARGET VEHICLE.

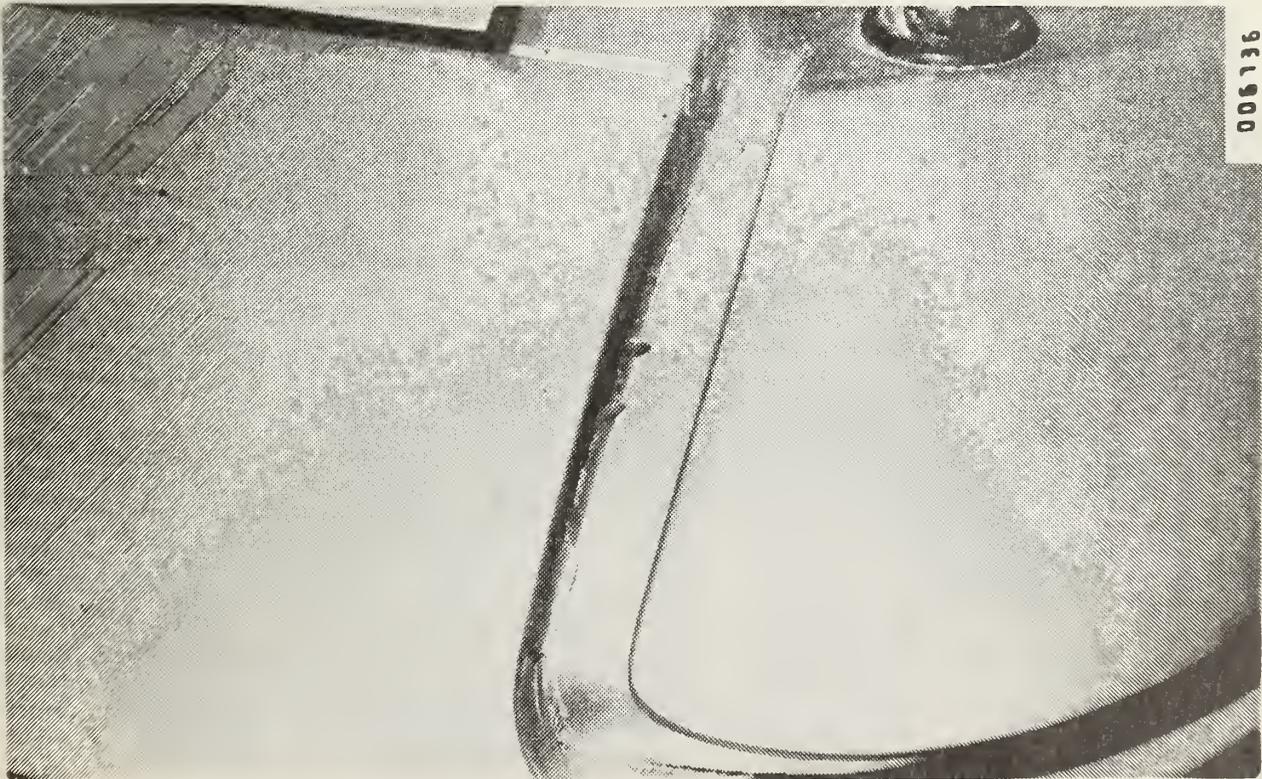
A second small crack appeared in the seam where the lateral panel below the rear hatch window mates with the right rear fender panel. As with the previously noted crack, this appeared to extend into the body putty (seam filler) only (see Figure C-4).

FIGURE C-4. POST-TEST NO. 1, CRACK IN REAR FENDER PANEL SEAM OF M5-11 TARGET VEHICLE.

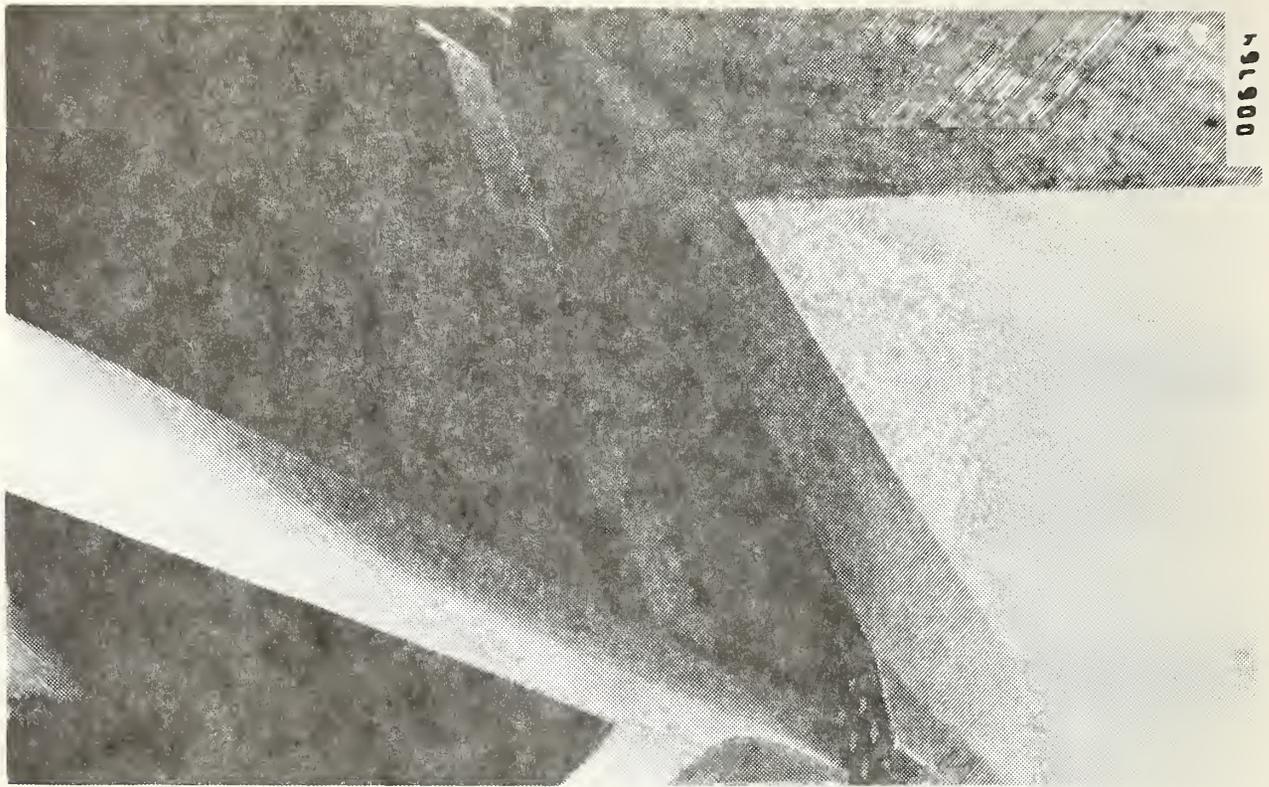
The bond line at the upper forward edge of the lateral panel below the rear hatch window failed, allowing the panel to translate upward approximately 1.5 inches (see Figure C-5). This action also caused a crack to appear in the fender seams adjoining this same panel, as shown in Figure C-6.

FIGURE C-5. POST-TEST NO. 2, BOND LINE FAILURE BELOW REAR HATCH DOOR OF M5-11 TARGET VEHICLE.

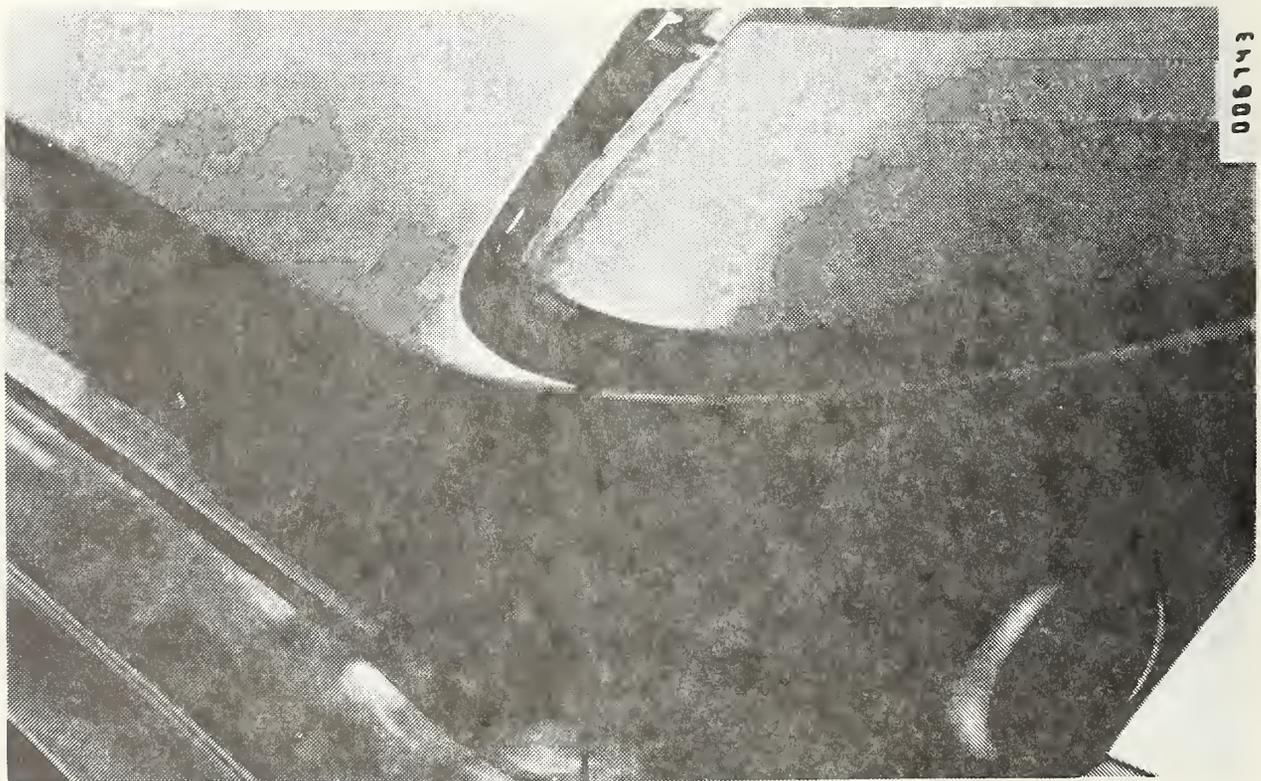
FIGURE C-6. POST-TEST NO. 2, CRACK IN REAR FENDER PANEL SEAM OF M5-11 TARGET VEHICLE.

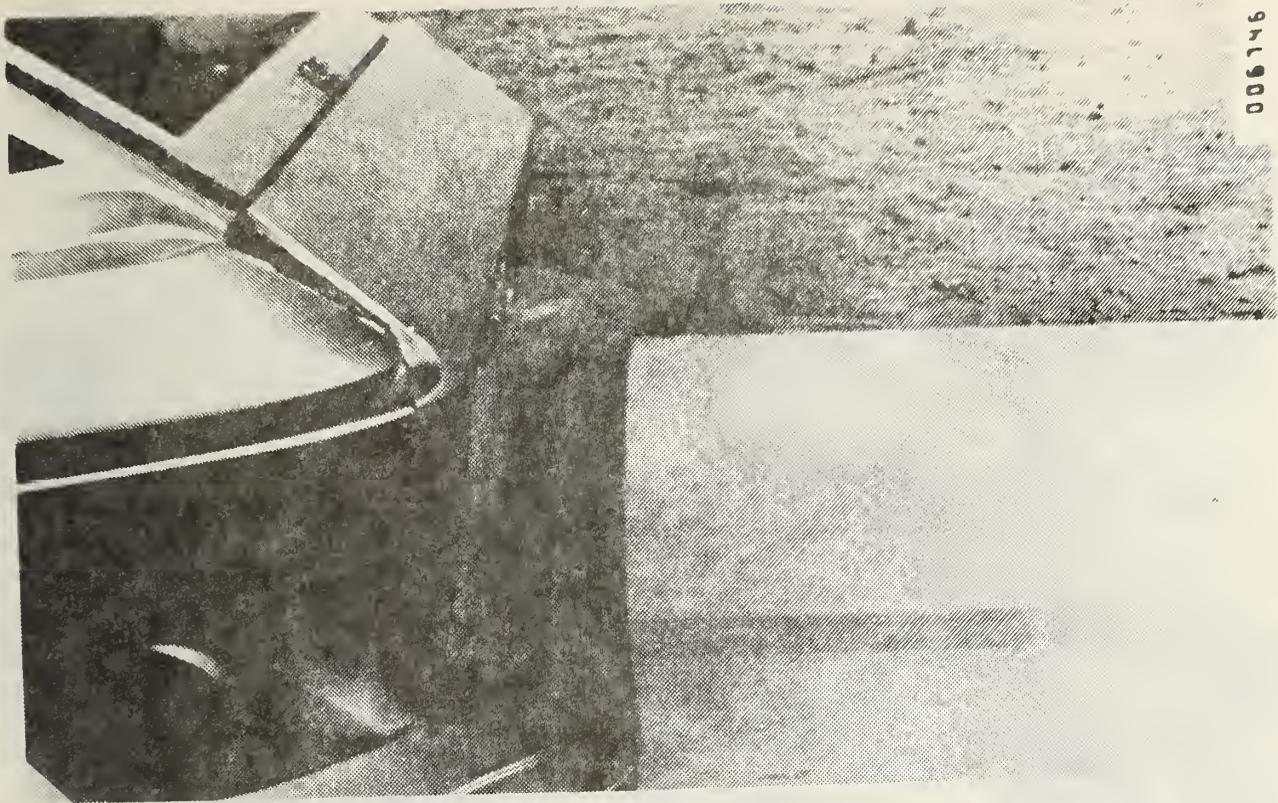
The rear bumper assumed a permanent bow as shown in Figure C-7. A slight bow was observed on the M5-11 vehicle upon delivery. This condition was exaggerated somewhat by testing.

FIGURE C-7. POST-TEST NO. 2, REAR BUMPER OF M5-11 TARGET VEHICLE.

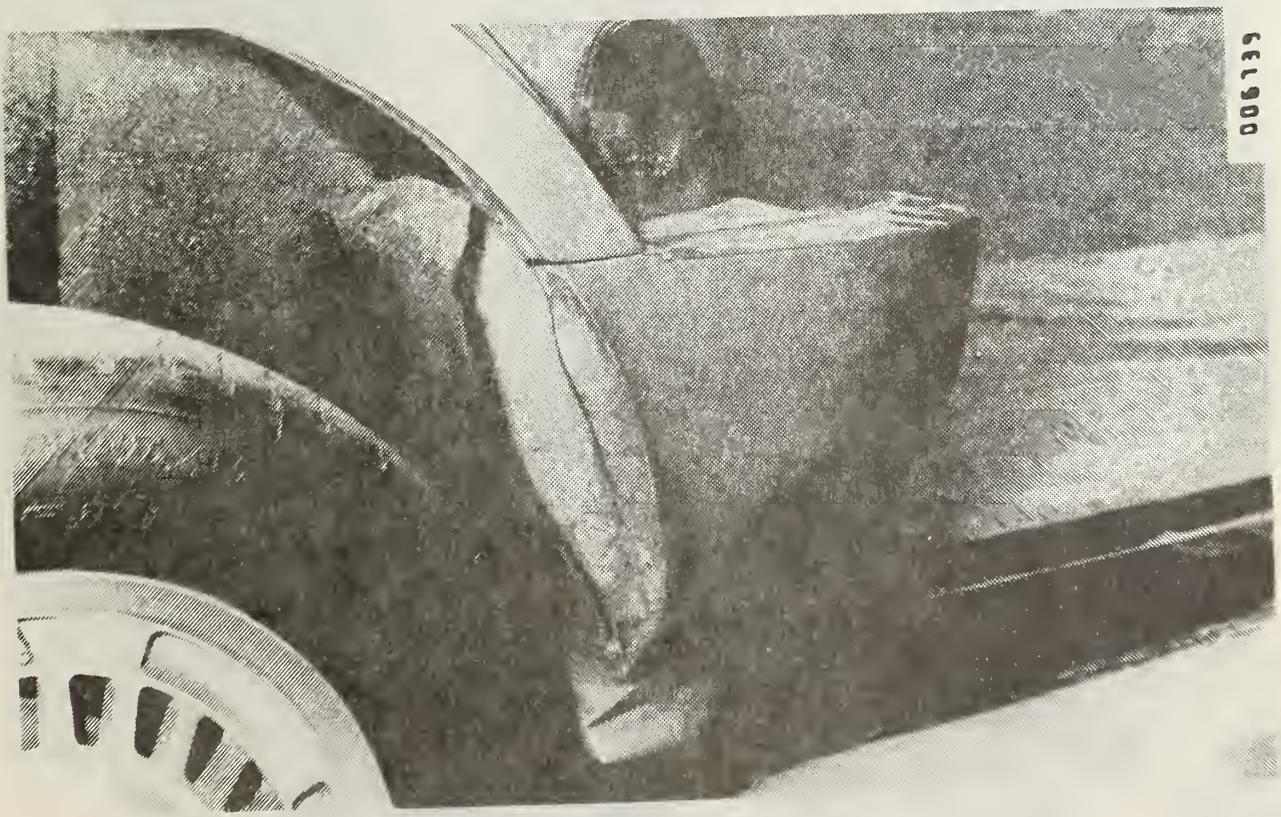
The left rear inside fender panel-to-fender bond failed, allowing the panel to fall forward as shown in Figure C-8.

FIGURE C-8. POST-TEST NO. 2, INSIDE LEFT REAR FENDER PANEL OF M5-11 TARGET VEHICLE.

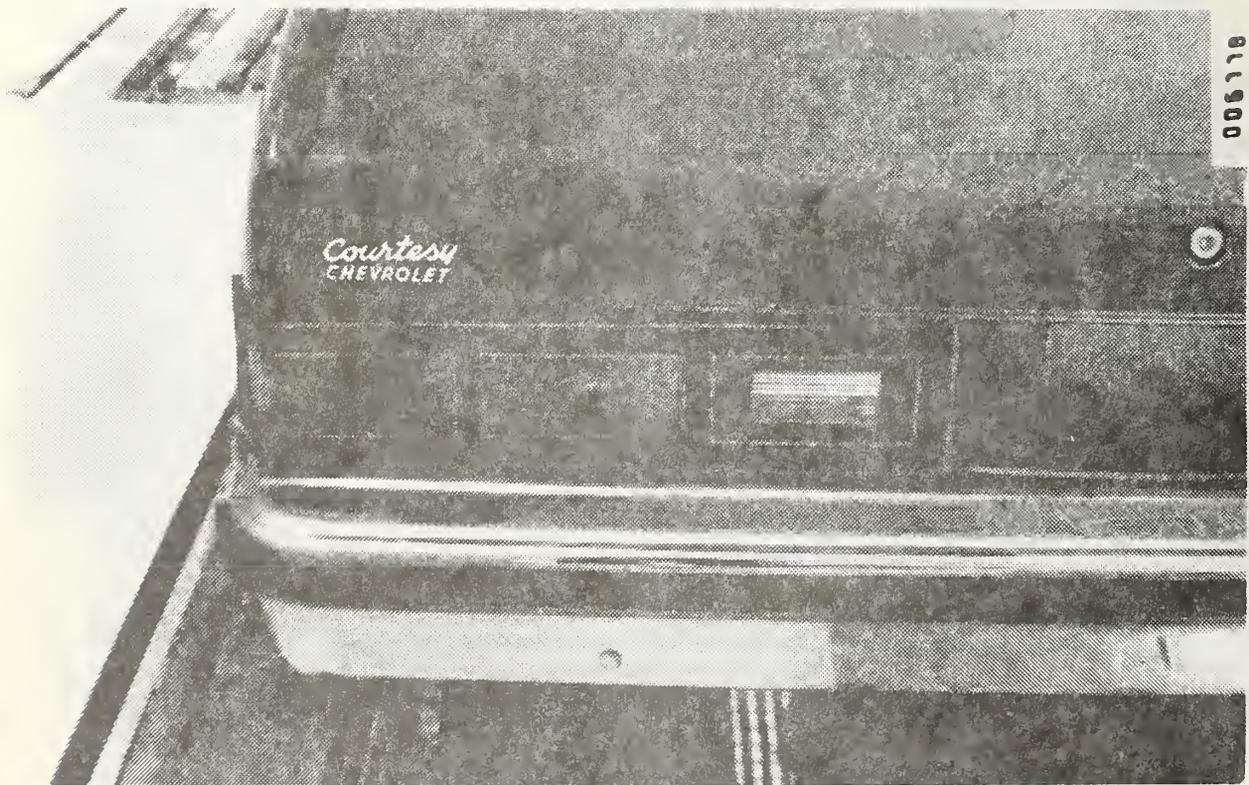
Both the left and right side taillight lenses cracked as shown in Figure C-13.

FIGURE C-13. POST-TEST NO. 3, REAR TAILLIGHT LENSE OF CHEVROLET CITATION TARGET VEHICLE.

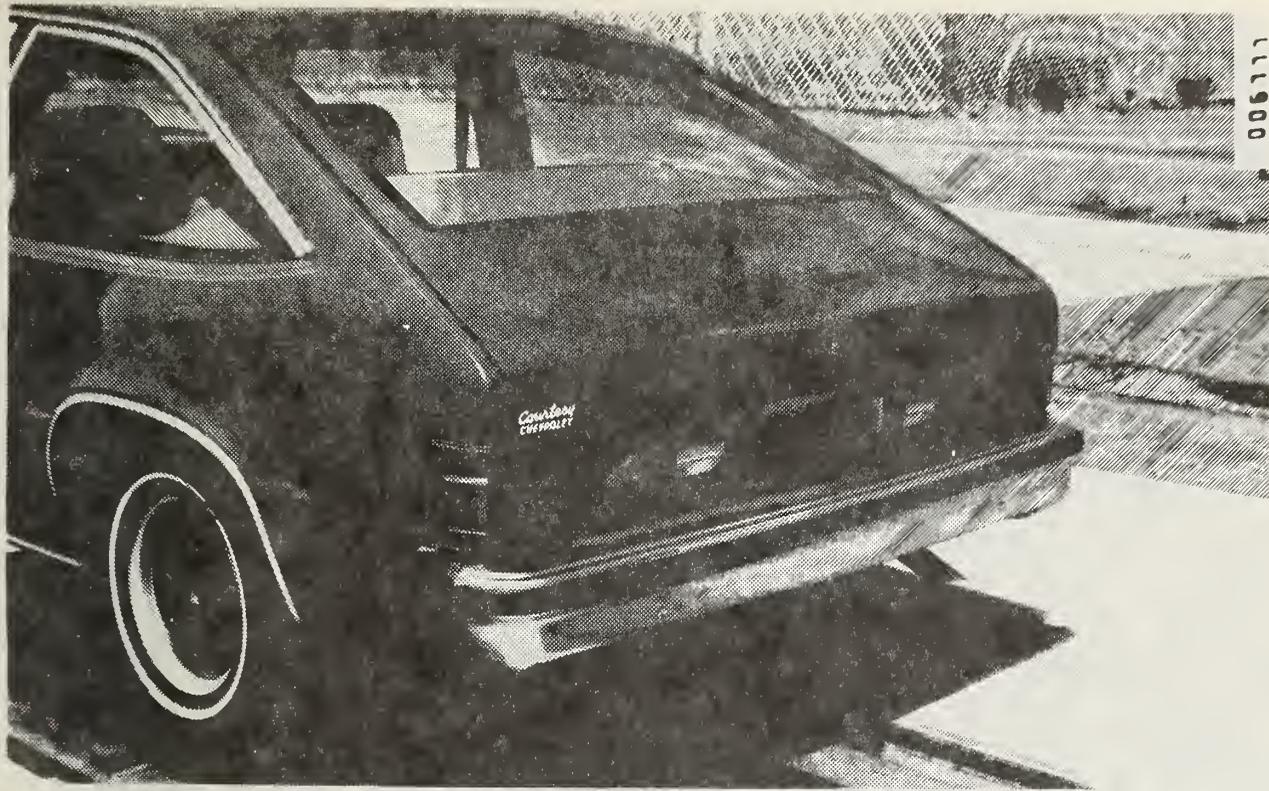
A small pressure buckle occurred near the upper rear corner of the fuel fill door and at a corresponding point on the opposite side of the vehicle (see Figure C-14). This photograph also shows the general downward movement of the rear of the vehicle when compared to the pre-test condition.

FIGURE C-14. POST-TEST NO. 3, REAR QUARTER PANEL OF CHEVROLET CITATION TARGET VEHICLE.

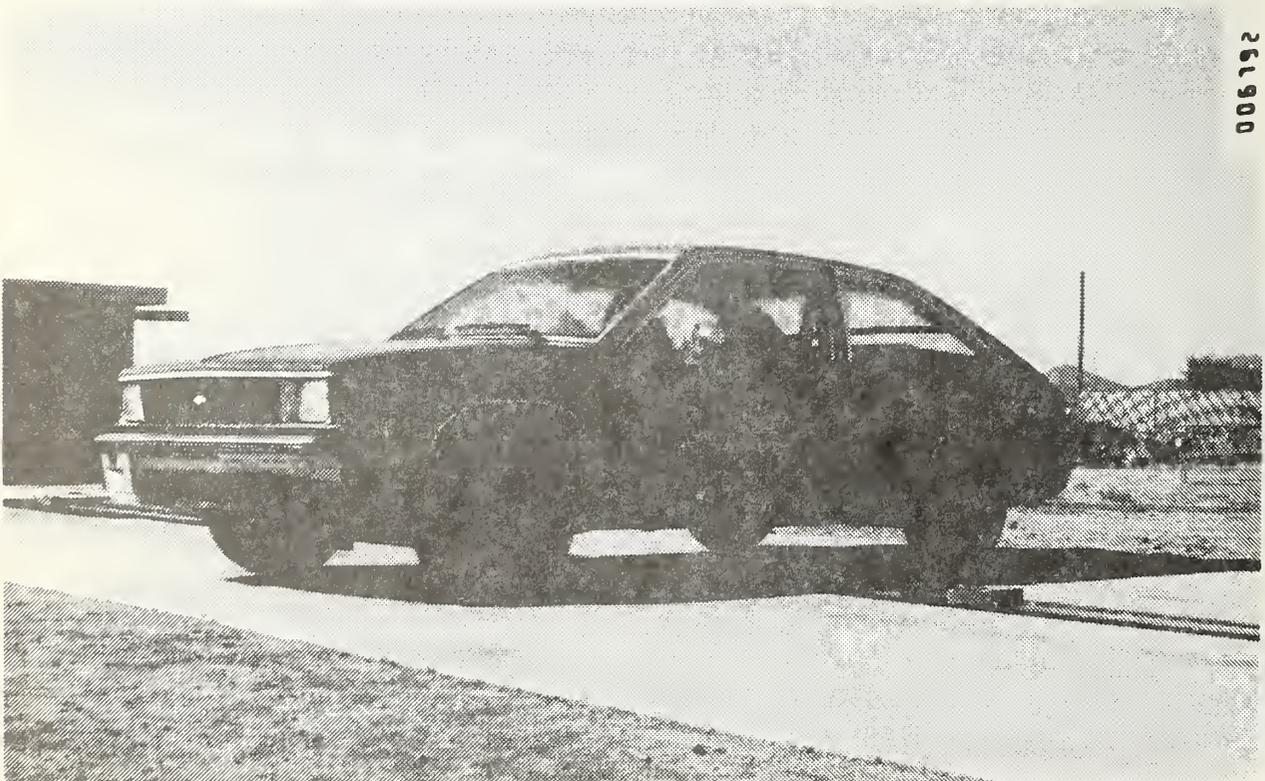
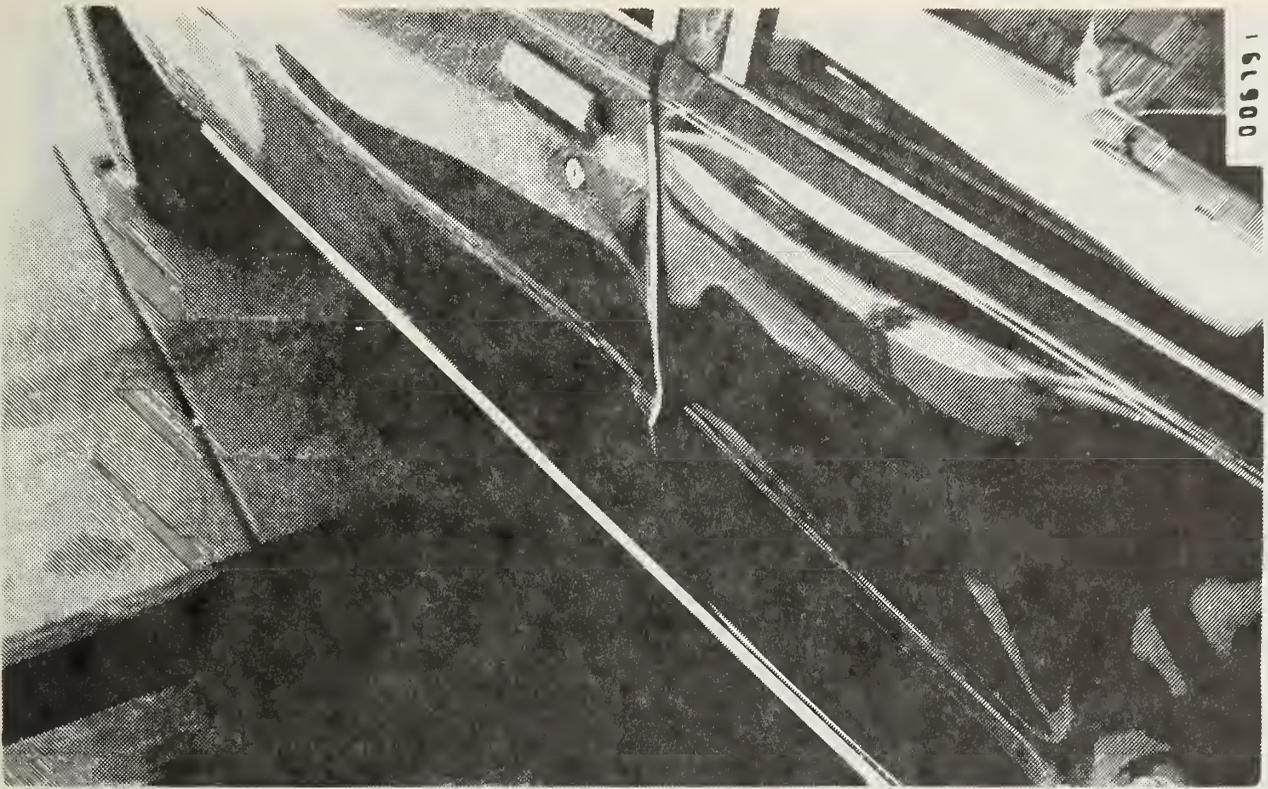
Obvious damage to the Chevrolet Citation was confined to the driver's door skin and lock pillar assembly. Maximum depression depth on the door skin was approximately 1.5 inches. The door opened and closed normally post-test, and the window remained intact and operational.

Probable damage occurred to the door frame and reinforcing beam behind the outer skin. Figures C-17 and C-18 present the post-test views of the vehicle.

FIGURE C-17. POST-TEST NO. 4, OVERALL VIEW OF CHEVROLET CITATION TARGET VEHICLE.

FIGURE C-18. POST-TEST NO. 4, LEFT SIDE DOOR OF CHEVROLET CITATION TARGET VEHICLE.

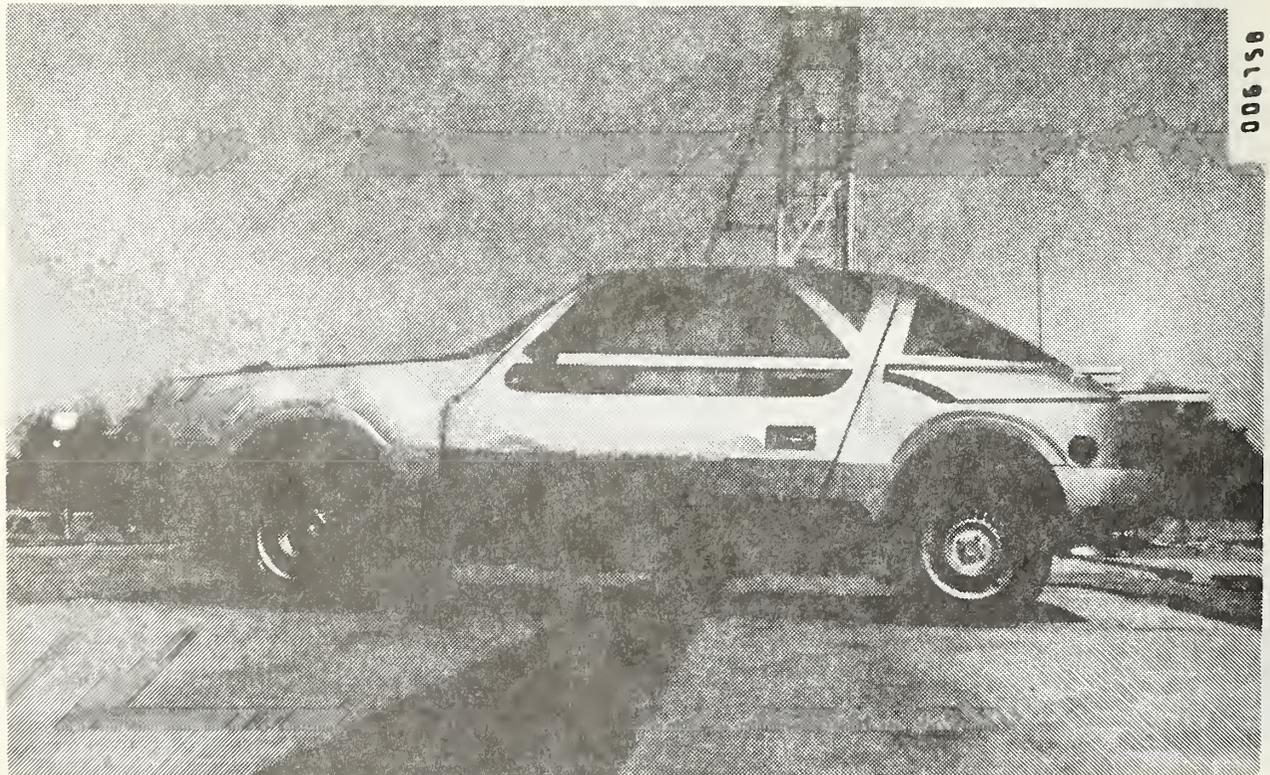
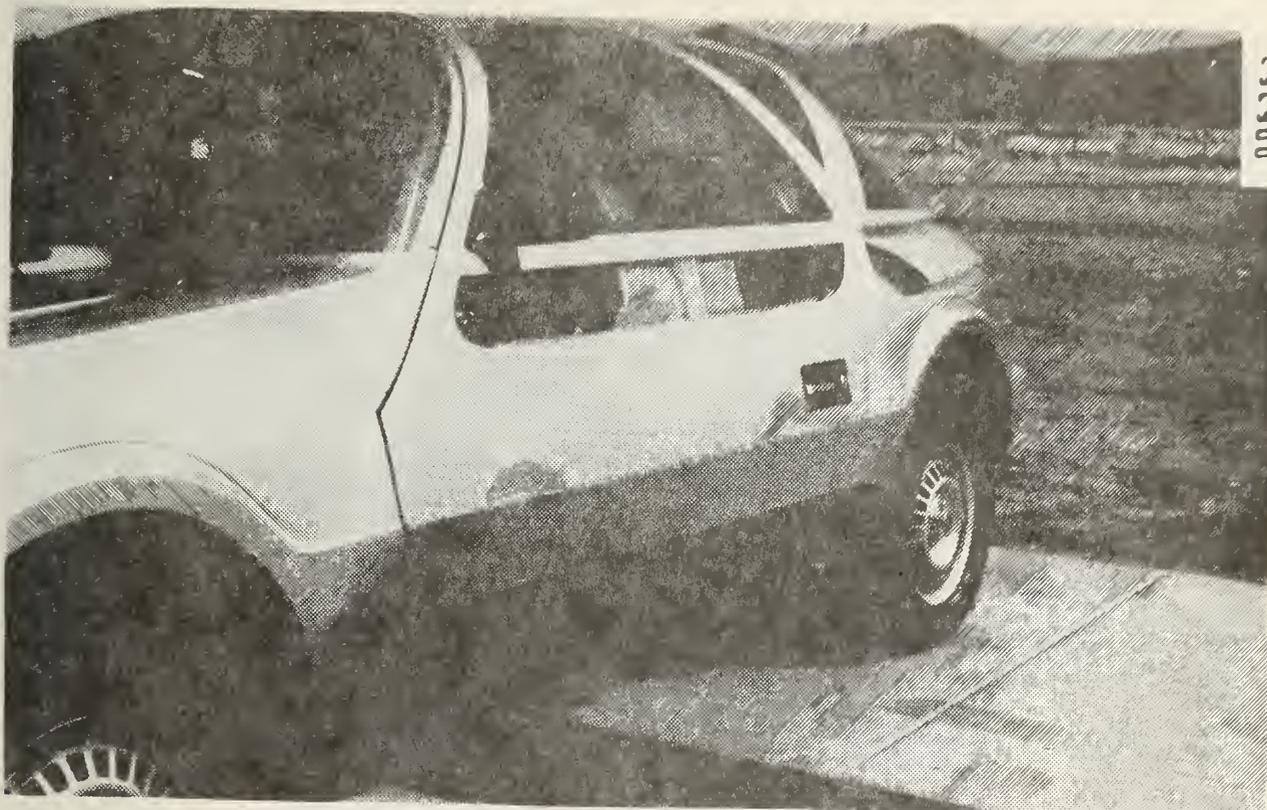
Two small impressions were left on the outer skin of the M5-11 target vehicle door, corresponding to the hard spots on the front of the bullet vehicle (projections tangent to insides of head lights). Width of these impressions was approximately 6.0 inches in each case, with a 4.5-inch vertical line evident in the rear impression that was not evident in the front impression. Post-test operation of the gullwing door was normal, with no damage apparent to any of the window surfaces. It was not determined whether any damage occurred to the reinforcing member behind the outer door skin.

FIGURE C-21. POST-TEST NO. 5, OVERALL VIEW OF M5-11 TARGET VEHICLE.

FIGURE C-22. POST-TEST NO. 5, LEFT SIDE DOOR OF M5-11 TARGET VEHICLE.

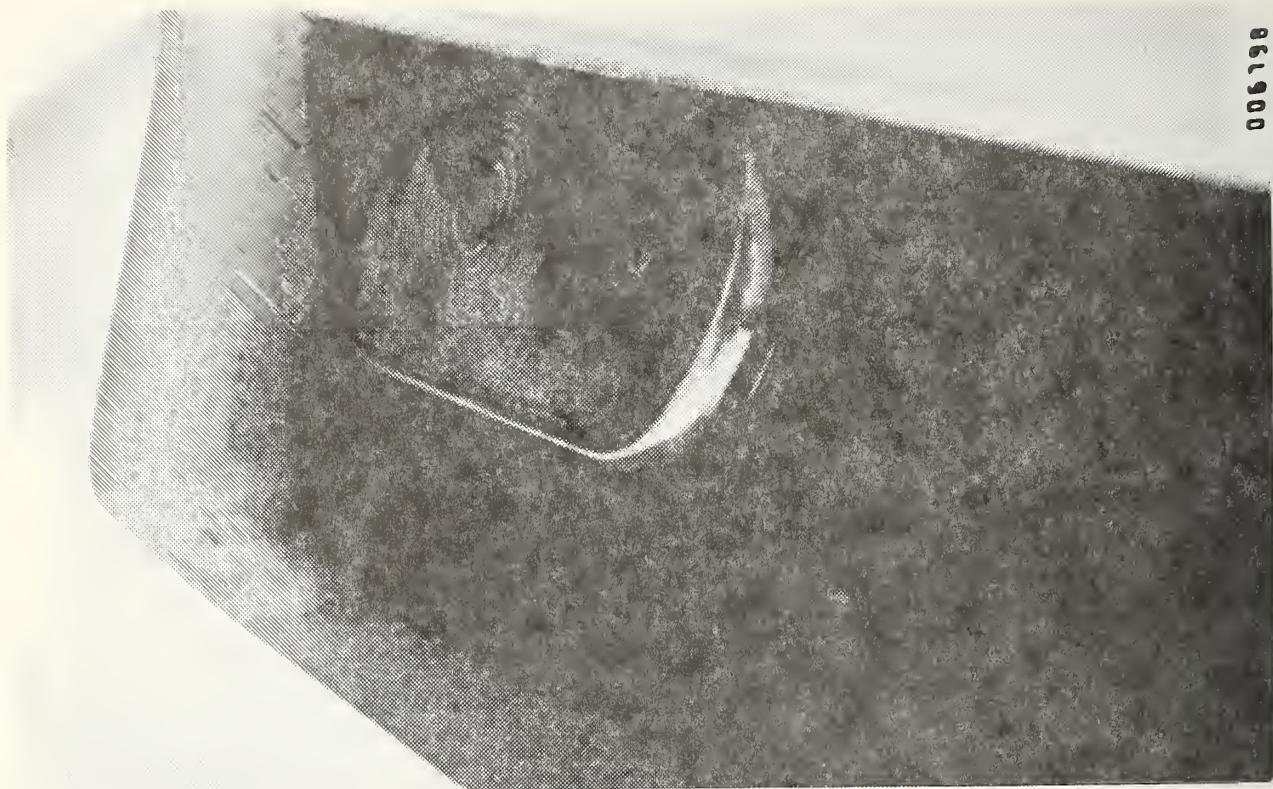
FIGURE C-24. POST-TEST NO. 6, RIGHT SIDE TURN SIGNAL LAMP AND FRAME OF M5-10 VEHICLE.

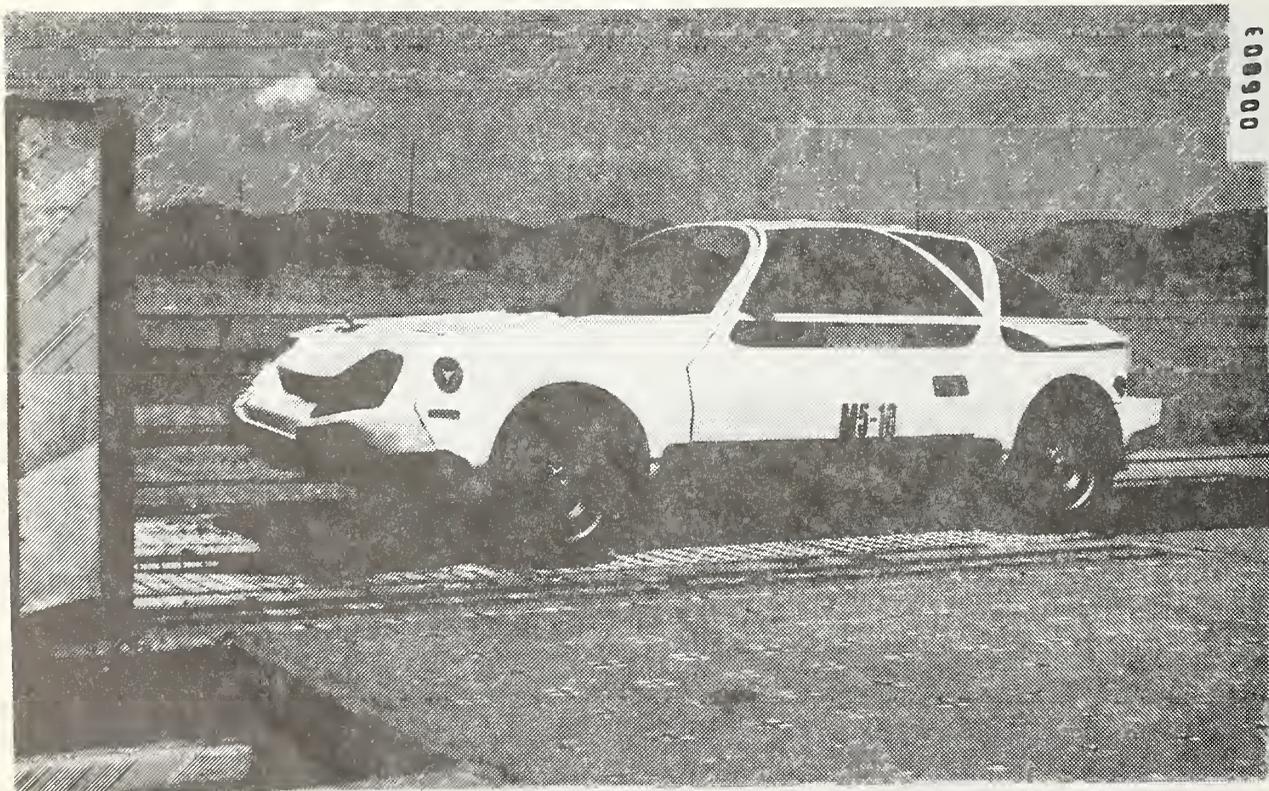
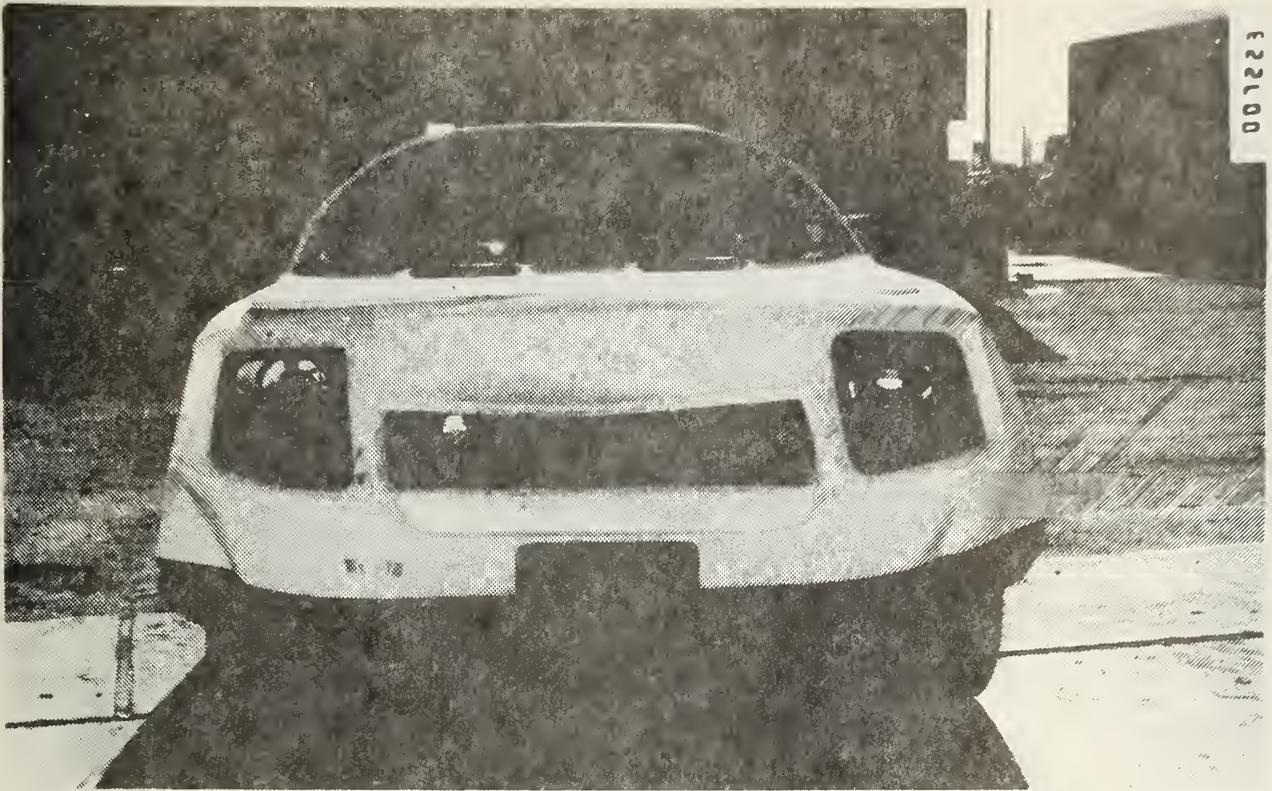
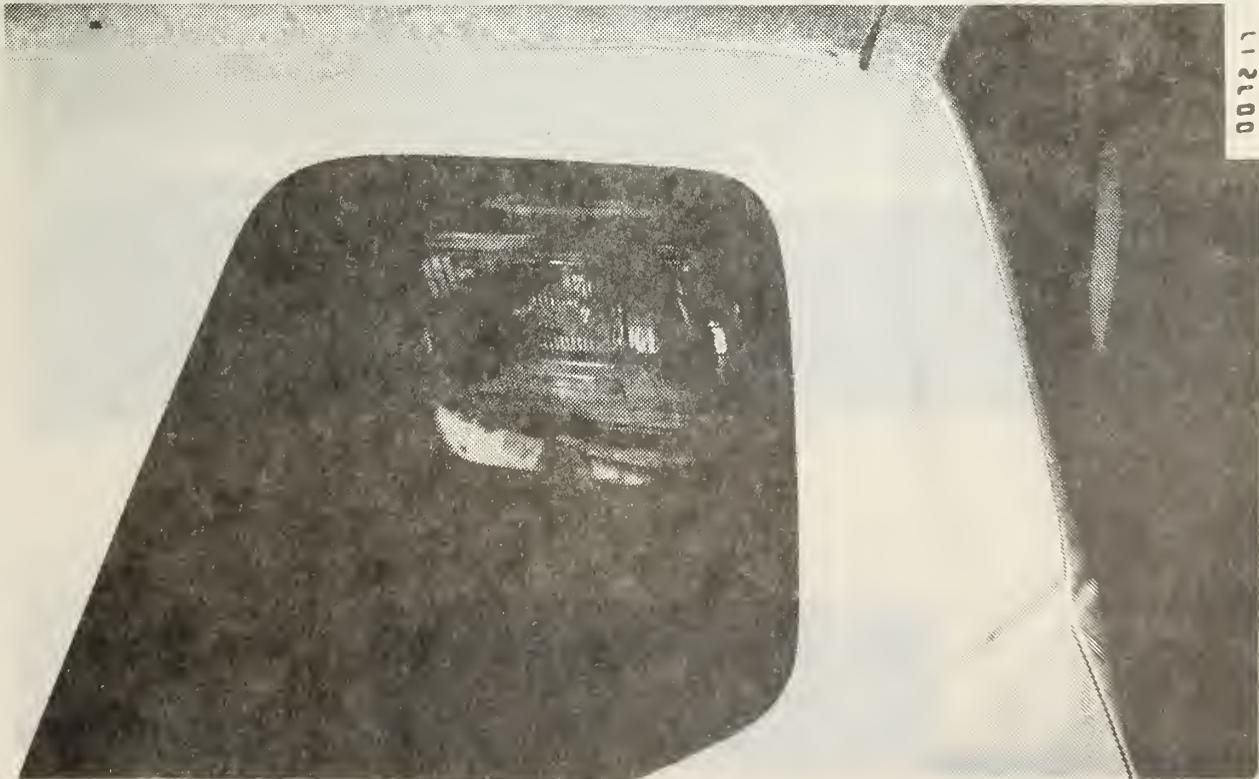
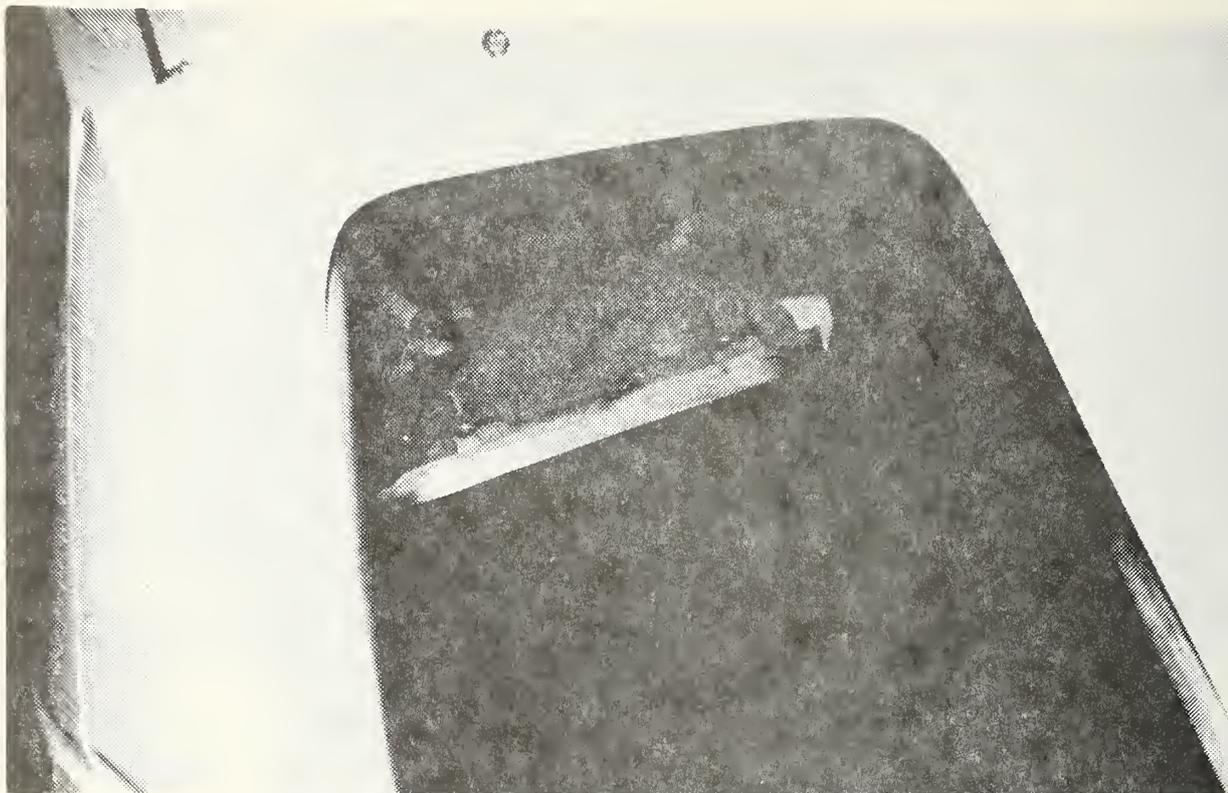
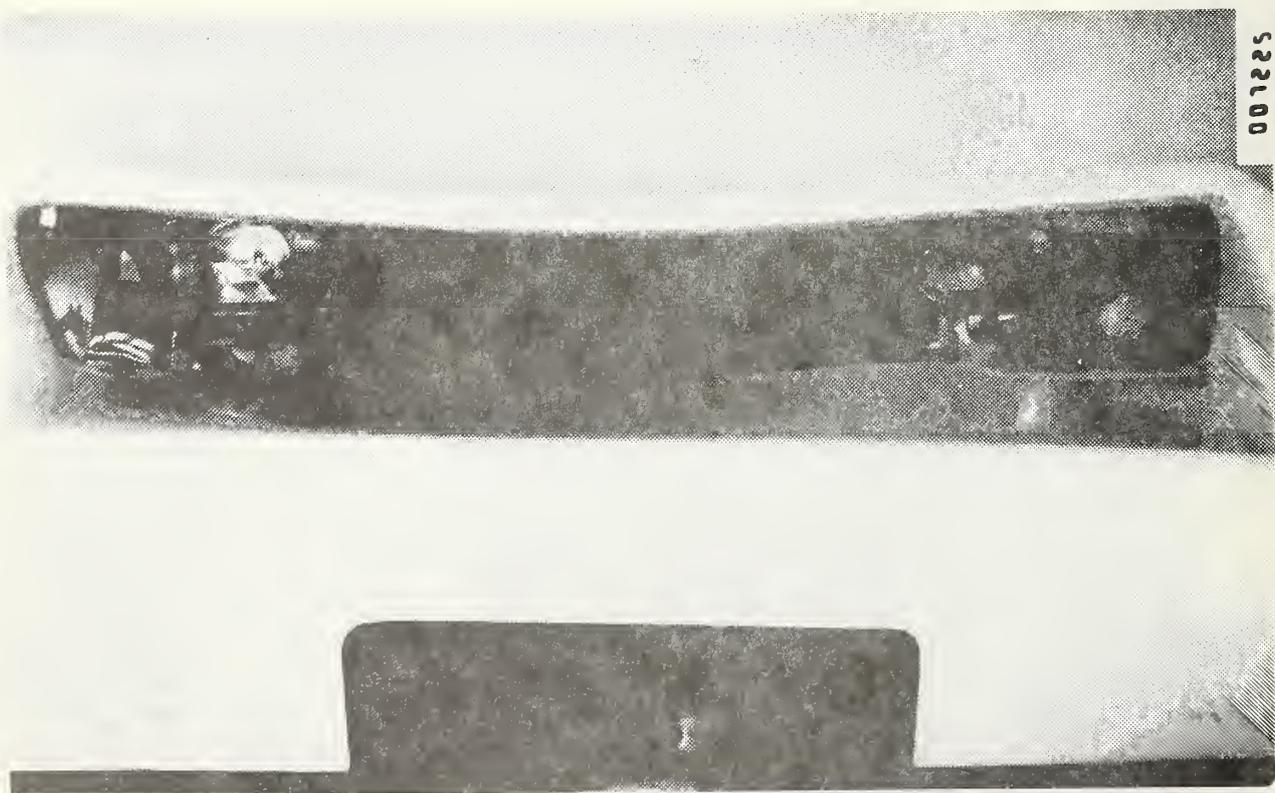
Both headlight units broke loose from their lower retainers. The left and right side turn signal lamps, along with their base plate, were forced rearward, resulting in residual translation of approximately 6.0 inches. Noticeable permanent deformation occurred across the entire lateral bumper face with some structural damage occurring across the entire front surface behind the bumper face. The vehicle was observed leaking coolant fluid due to a broken feed line and/or torn radiator hose.

FIGURE C-25. POST-TEST NO. 7, OVERALL VIEW OF M5-10 VEHICLE.

FIGURE C-26. POST-TEST NO. 7, FRONT VIEW OF M5-10 VEHICLE.

FIGURE C-27. POST-TEST NO. 7, LEFT SIDE HEADLIGHT - M5-10 VEHICLE.

FIGURE C-28. POST-TEST NO. 7, RIGHT SIDE HEADLIGHT - M5-10 VEHICLE.

FIGURE C-29. POST-TEST NO. 7, TURN SIGNAL LAMPS AND MOUNTING FRAME - M5-10 VEHICLE.
